Intel[®] Mobile Celeron[™] Processor at 466 MHz, 433 MHz, 400 MHz, 366 MHz, 333 MHz, 300 MHz, and 266 MHz Specification Update

Release Date: December 2000

Order Number: 244444-021

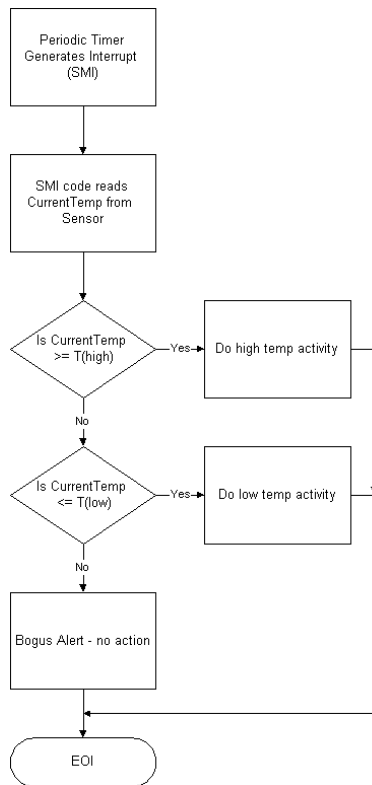
Figure 3. Workaround Flowchart: SMI#-Driven System

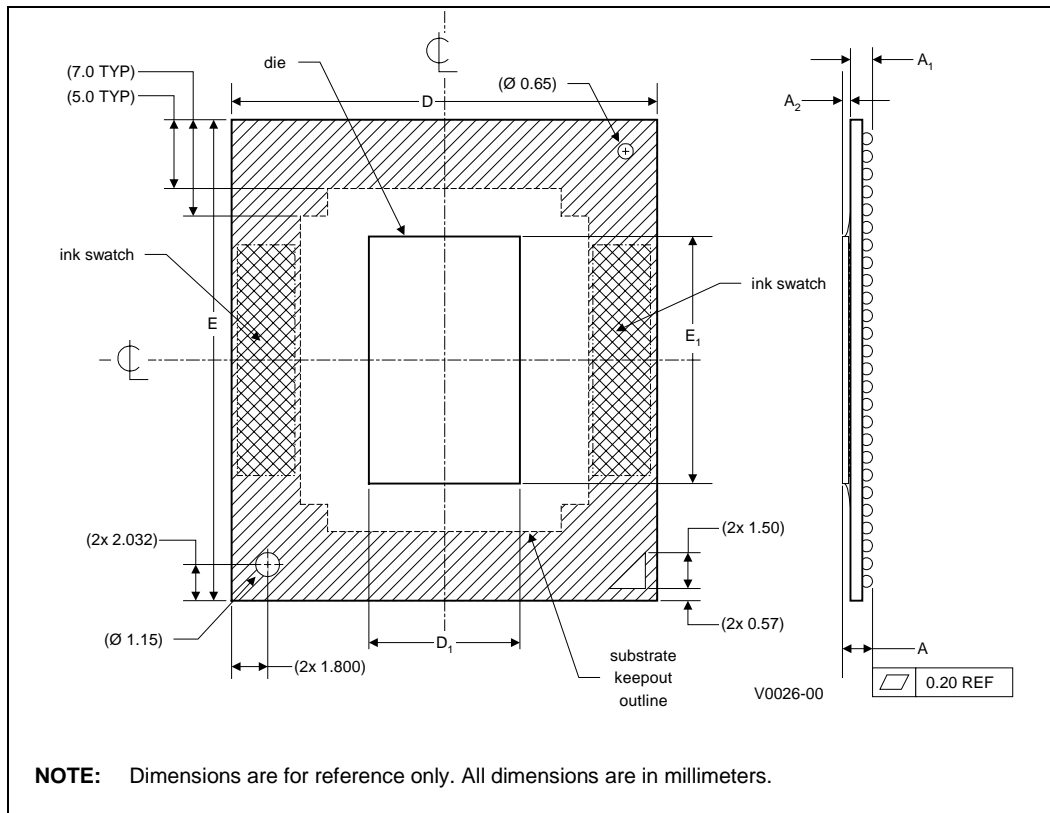
Figure 5.3. Surface-Mount BGA1 Package—Top and Side View

The following table and figures show the updated mechanical specifications for the BGA1 package, listed as Table 5.2, Figure 5.3 and 5.4, respectively, in the *Intel® Mobile Celeron™ Processor in BGA Package at 333 MHz, 300 MHz and 266 MHz* datasheet.
